VILLAGE OF MONTROSE

2017 ANNUAL REPORT OF WATER MONITORING

June 2018

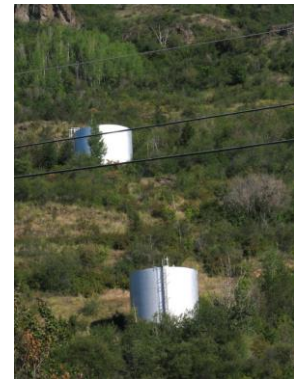
Reservoir #1 (lower) was constructed in 1959. It is an elevated steel-finished tank consisting of one cell and has a storage capacity of 455m³. Its full water level elevation is approximately 637 metres.

Reservoir #2 (upper) was constructed in 1979. It is also an elevated steel-finished tank consisting of one cell and has a storage capacity of 909m³. Its full water level elevation is approximately 689 metres.

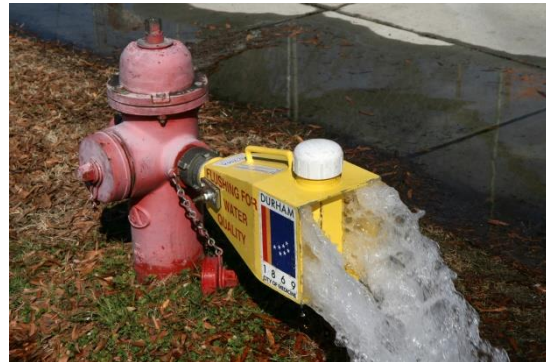
In 2011, TRUE Consulting was engaged to provide the Village with a formal unidirectional flushing (UDF) program for the annual flushing of watermains. The 2017 annual flushing program was completed in the spring and fall. The Village also maintains hydrants within the Village where the mains are also exposed to flushing activities.

Hydrants are inspected yearly to determine the unit's ability to function properly, and to provide adequate fire protection. Village staff performs inspections such as checking the hydrant pressure, exposing any worn parts, and updating service records. In 2009, the Village began a program to include capital funding to allow for any required replacement of older fire hydrants.
