VILLAGE OF MONTROSE

2020 ANNUAL REPORT OF WATER MONITORING

May 2020

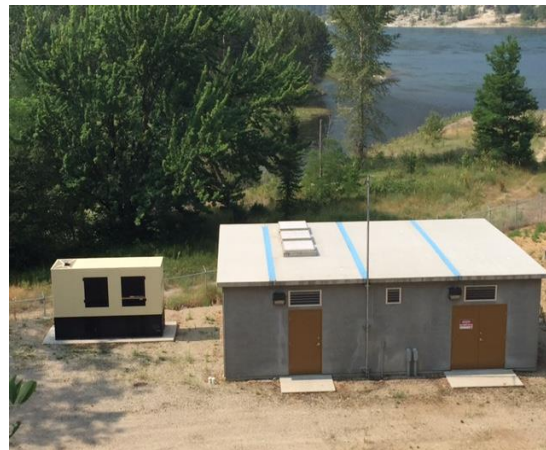
Chlorine is injected at the Water Treatment Plant at a rate of 0.75 – 1.0 mg/l with the majority of the distribution system seeing concentrations of 0.5 – 0.7mg/l. The injection rates fluctuate during the year with the minimum requirement of 0.2 mg/l residual at distribution system extremities used as a control. There are many challenges in maintaining these limits and dead-end main lines, dual pressure zones, water use and temperatures all affect the required chlorine residual.

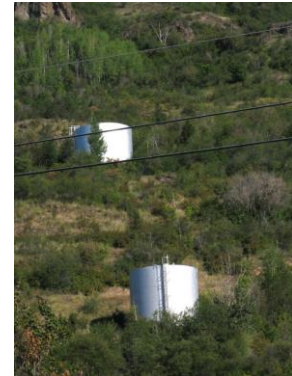
Reservoir #1 (lower) was constructed in 1959. It is an elevated steel-finished tank consisting of one cell and has a storage capacity of 455m³. Its full water level elevation is approximately 637 metres.

Reservoir #2 (upper) was constructed in 1979. It is also an elevated steel-finished tank consisting of one cell and has a storage capacity of 909m³. Its full water level elevation is approximately 689 metres.

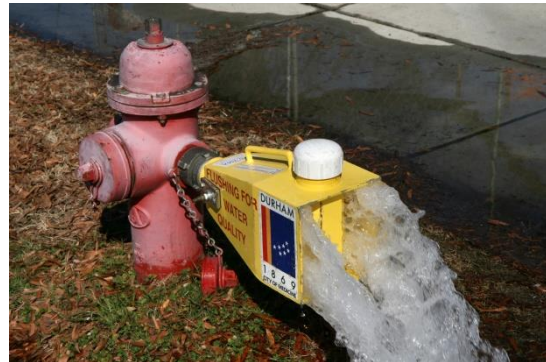
Hydrants are inspected yearly to determine the unit’s ability to function properly, and to provide adequate fire protection. Village staff performs inspections such as checking the hydrant pressure, exposing any worn parts, and updating service records. In 2009, the Village began a program to include capital funding to allow for any required replacement of older fire hydrants. A total of two old hydrants were replaced and one new unit was added in 2020.

This program continued in 2020 and saw the replacement of two hydrants and the addition of one other unit.
